Vertically Challengeo What have they done to fix it?

Latest Solution

HE ENGINEERING SOLUTION

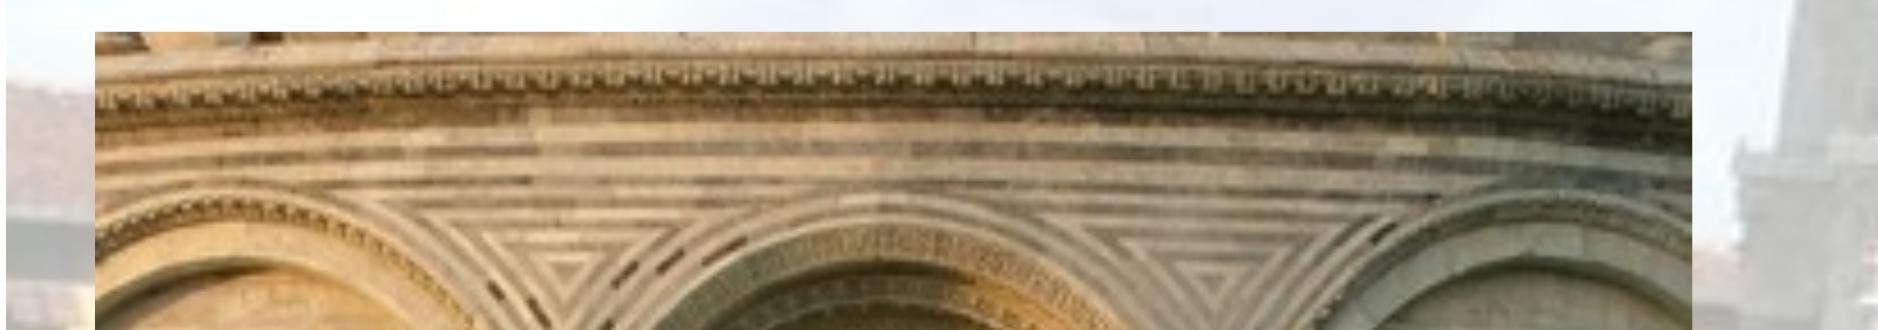
The unsightly lead weights used to hold of the Leaning Tower of Pisa. (Feuerstein)

This borderline miraculous tower barely overcame the next two attempts at verticality. The next venture to right the tower included slowly adding 600 tons of lead weights to counter the lean. (Apsell) The weights were stacked near the tower, over a four to five month period, in hopes to hold it upright. See Figure 2. The tilt became under control for the first time in 800 years. (Apsell) However, the magnificent tower was becoming unsightly from the ugly lead weights, ruining the much sought after appearance of the tower. By trying to save the tower, the integrity of the building became compromised. Since the tower has defied all odds up to this point, there's a chance that it will not collapse anytime soon. In that case, the ugly lead weights should no longer be an option. In order to get rid of the hideous weights on the outside of the tower, the latest idea was put to the test. This

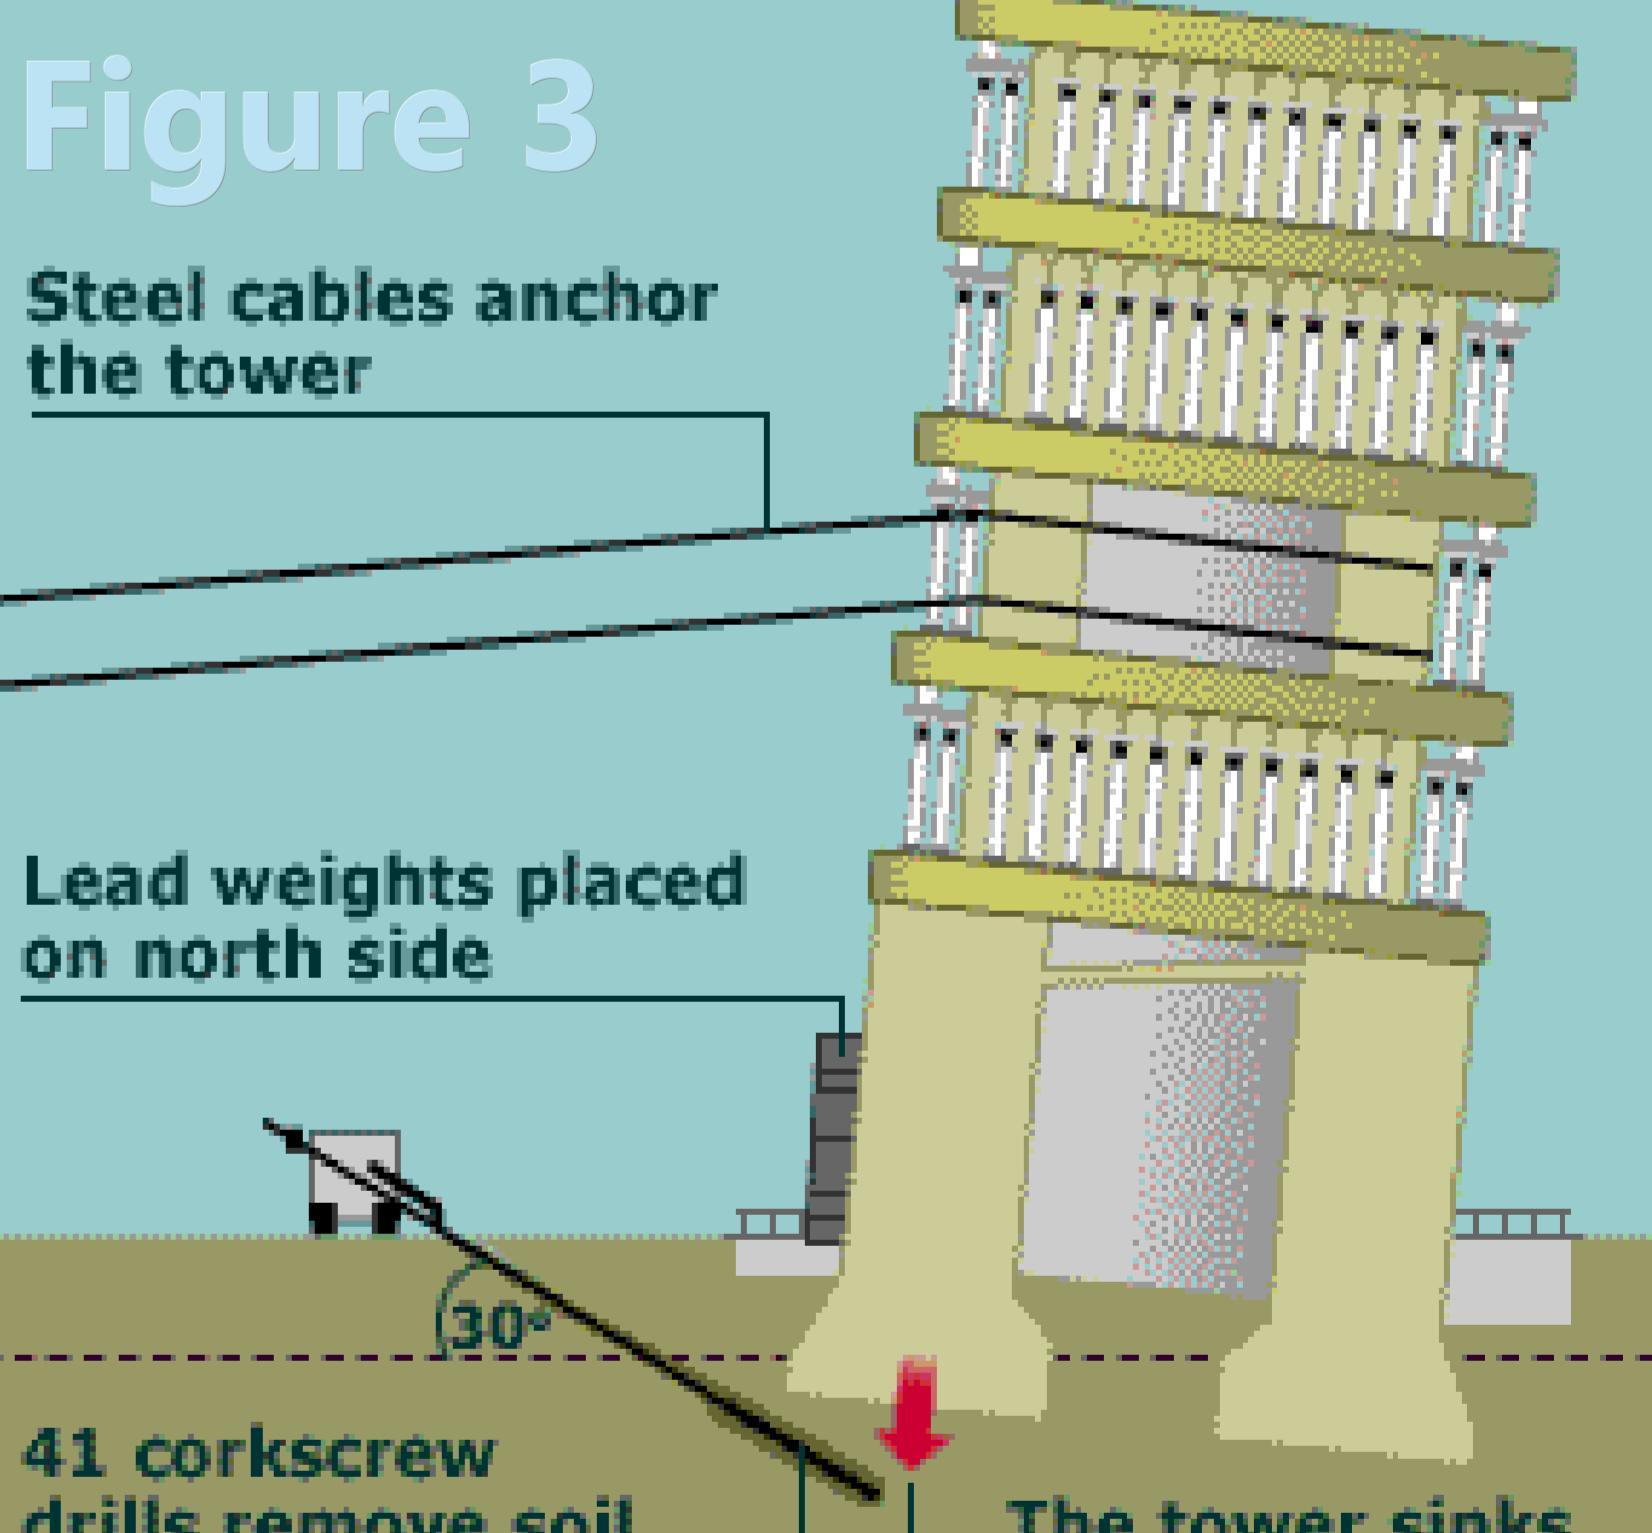
drills remove soil

The tower sinks into the cavity

A diagram illustrating the soil extraction method. (Mulvey)

Engineers decided a permanent solution was needed that would keep the integrity of the Leaning Tower of Pisa in tact. The underlying question becomes: to what extent should the tower be fixed? Obviously, they could not possibly straighten the tower completely. What would they name it- Your Normal, Everyday Tower of Pisa? In reality, the tower needs to be reinforced somehow, otherwise the tower will no longer exist. After many years of debate and many diverse engineers' opinions, a solution has been proposed and they like to call it soil extraction. The basic essence of this idea is to remove soil from underneath the north side of the tower. A drill will be inserted under the tower and when it is pulled out, the soil will fill in the cavity, thereby reducing the lean. (Apsell) See Figure 3. This strategy should reduce the inclination by approximately ten percent, or about one half of a degree. (Apsell) According to experts' calculations, this should add at least 300 years to the tower's lifetime. (Apsell) However, it is still very risky and some people are wondering if it is worth it. To take extra precaution, a heavy metal harness would be gently holding the tower in case of any large movements and numerous machines would be monitoring the tower at all times. (Apsell) Thus far, the soil extraction method has been very successful and it is already slowly moving north. (Apsell) This architectural miracle will probably have many surprises to come, but hopefully none of those surprises will be catastrophic. Everyone deserves the opportunity to see this great world wonder.
